Tom Keeling - Technical Memo 2021/1 – v1

For Sea Otter Owners Club – 8th May 2021

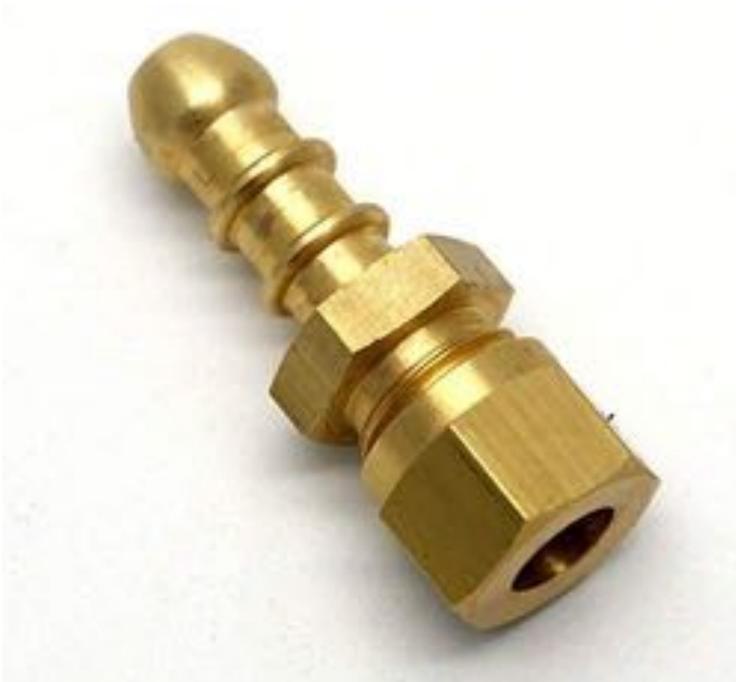
Photo 1

A suitable nozzle looks like this. This is a Fulham nozzle on one end and 8mm compression union at the other. The compression end connects to the copper gas pipework or an inlet connector on an appliance and the nozzle end takes the hose and clip.

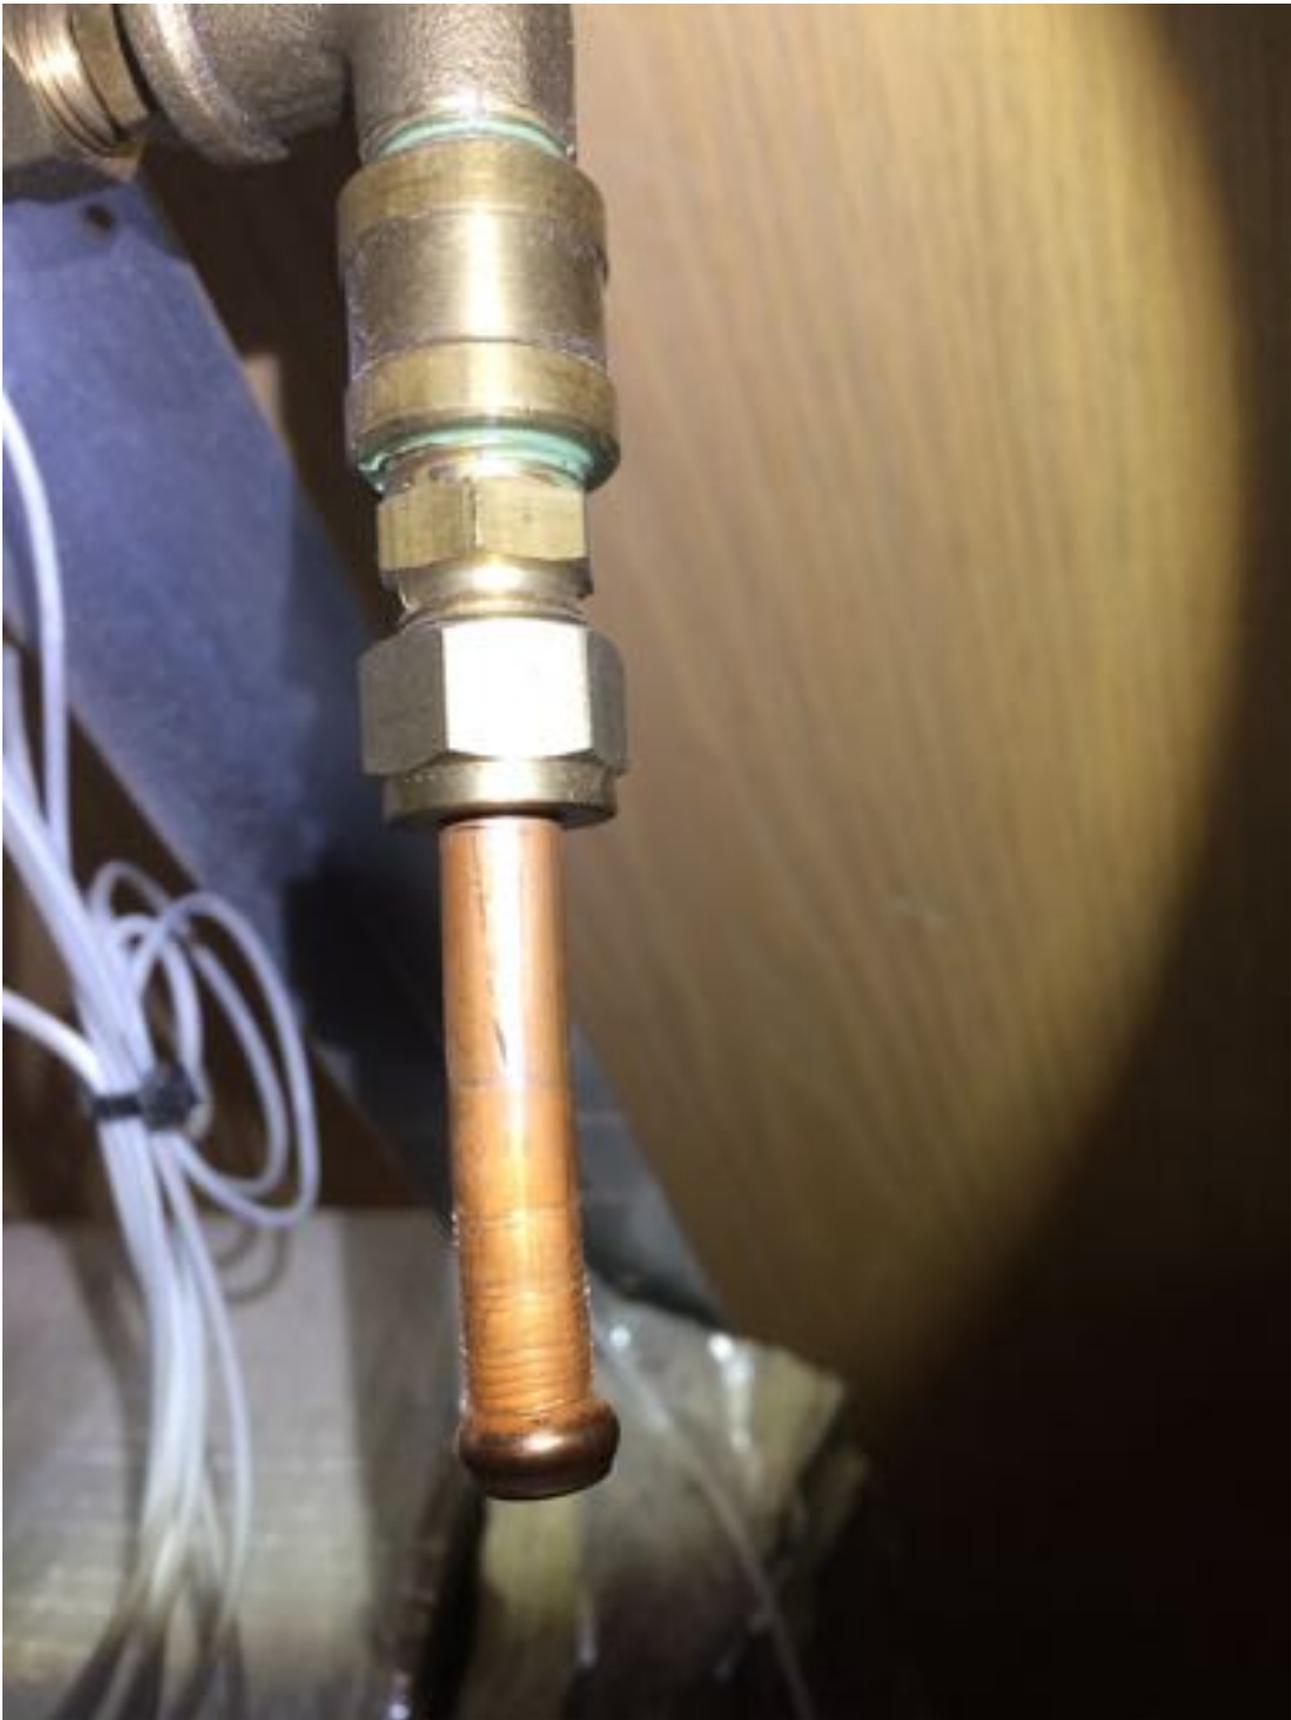
Photo 4

This is an incorrect joint showing the hose joining the copper tube to a nozzle. Fails at BSS check item 7.9.5R on this 2012 Sea Otter.

The 2012 and 2013 boats with the incorrect nozzles had to have Fulham nozzles fitted in one case, and in the other some minor changes to pipework and a pre-made swaged end hose fitted to get a BSS pass. A local gas safe registered engineer can no doubt provide further advice if required.

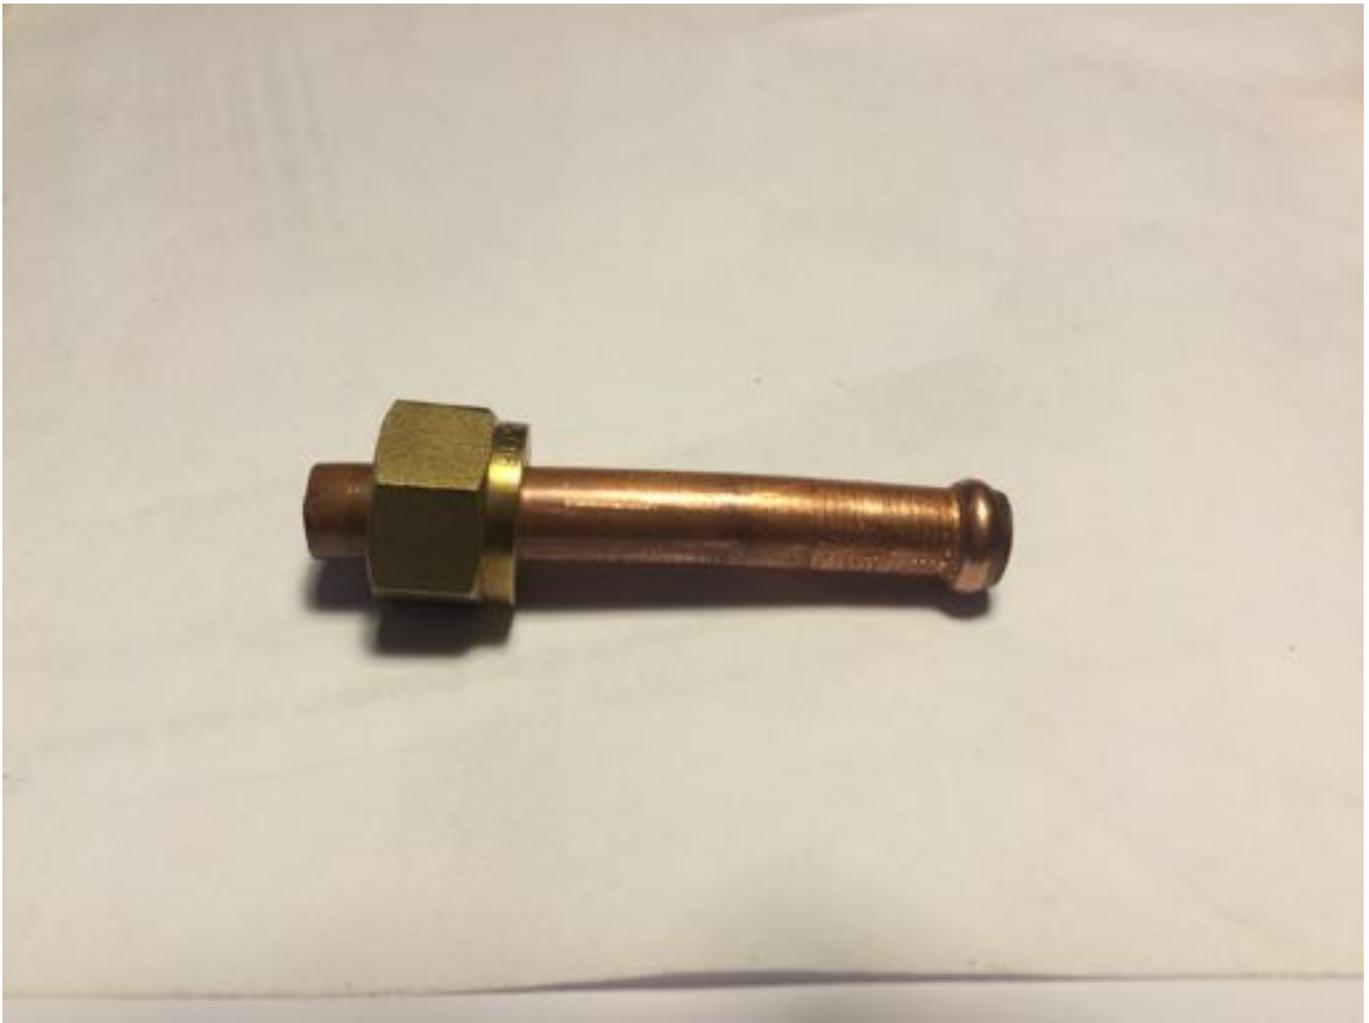
Photo 5

With the hose removed – the BSS do not accept this nozzle as being suitable.

The BSS requires a suitable nozzle but does not detail in the public facing information what that is. I recently asked and they clarified that they require the nozzles to be of proprietary manufacture e.g. like a Fulham nozzle because that has been designed specifically for use with gas hose, and will adequately secure the hose, particularly where movement is possible. The nozzle shape is also designed to prevent damage to the internal wall (as opposed to say a water hose nozzle which has machined sharp barbs). It is worth pointing out that having seen a few of the non-compliant nozzles now, they are not uniformly made, not straight, and not strong.
