Waterways World

Understanding Boat Surveys

A survey is the only way of assessing the true health of a steel narrowboat. Marine surveyor and chartered engineer **Tom Keeling** explains the processes and offers advice

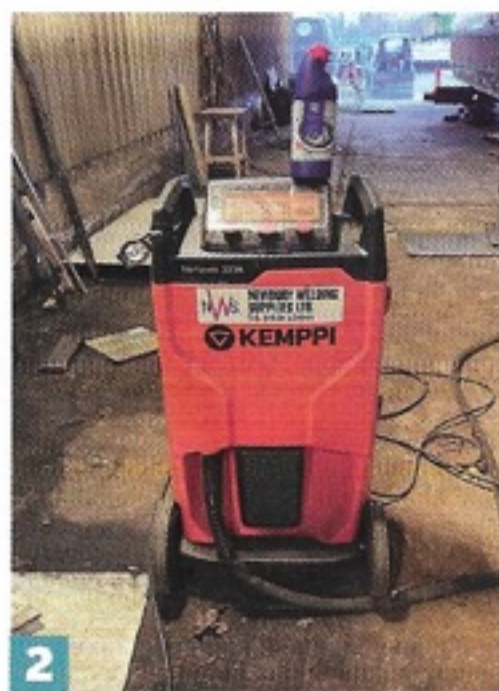
2 & 3 The three-phase MIG welder, a fabricator coded to BS EN 9606-1, and the covered workshop at Oxford Cruisers make ideal repair facilities for steel hulls.

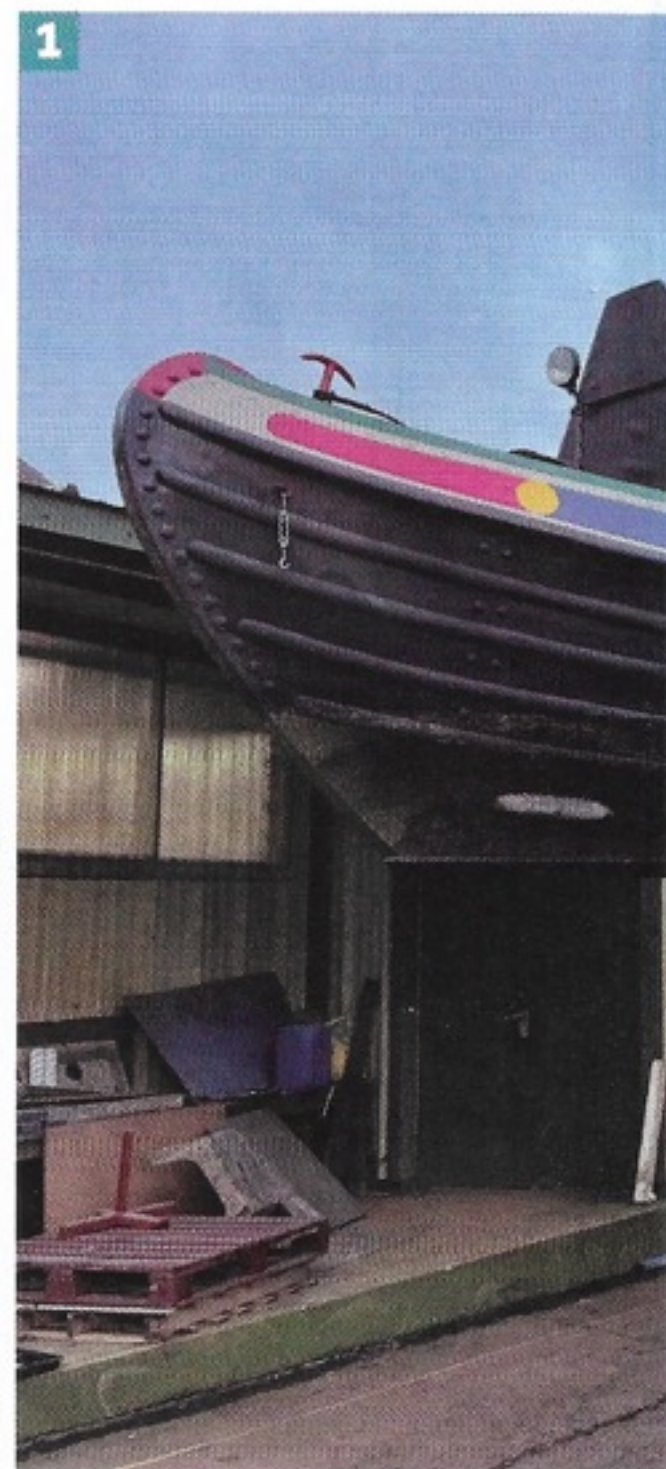
1 A gantry lift and stands at Debdale Wharf allow full access to the underside of a boat.

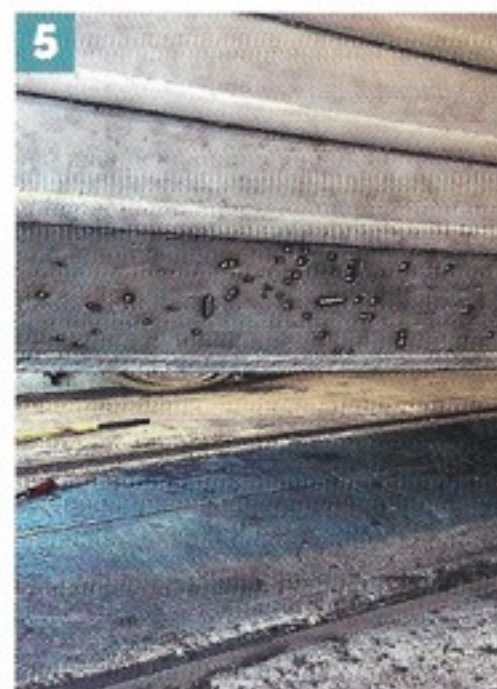
5 Deep pitting of this hull was identified after grit-blasting, and has subsequently been welded up.

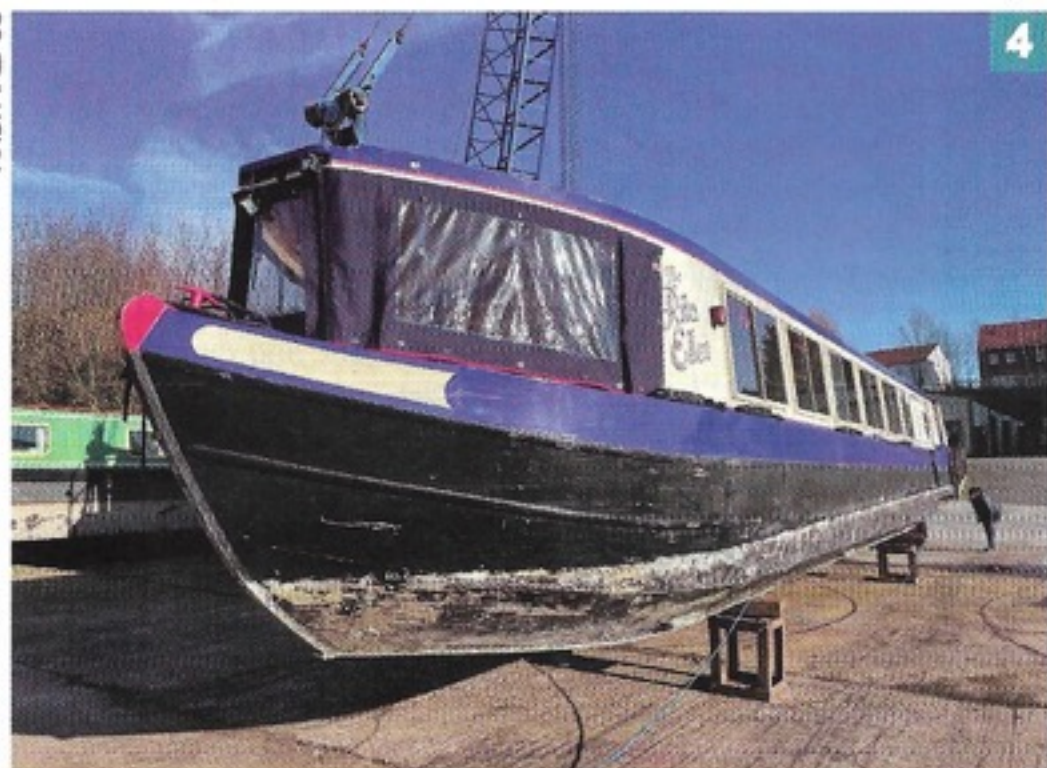
4 Stratford trip-boat *Rita Ellen* craned out on to hardstanding at Evesham Marina.

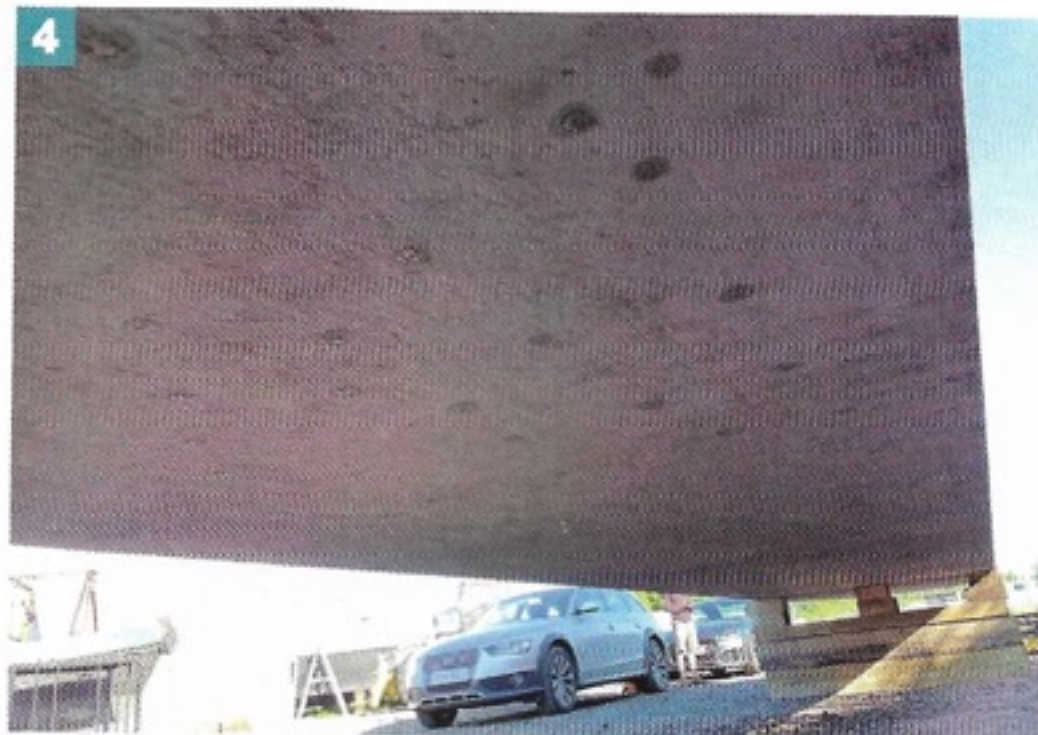
5 Post-survey the base plate transverse joints were rewelded and the plating was epoxy coated to prevent pitting from worsening.

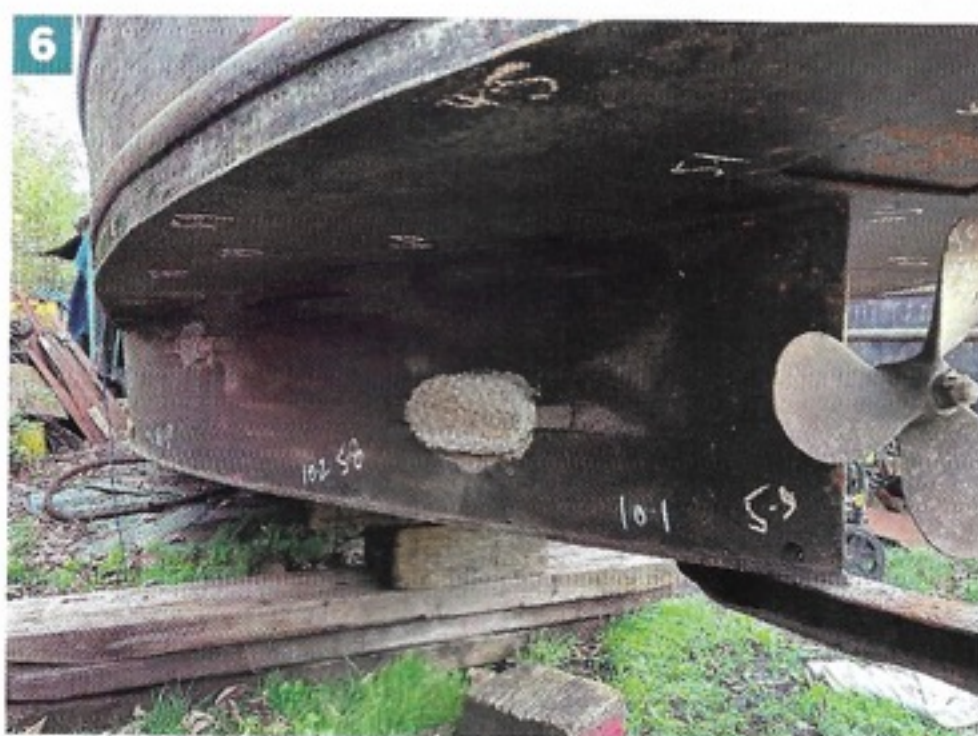
6 Thicknesses are marked on the hull in chalk...

7 and are later transferred to a plan that's included in the report.
